Excavation and Conservation at Volubilis, 2004

Elizabeth Fentress, Hassan Limane
and Gaetano Palumbo

The Restoration and the *mise en valeur* of the Idrissid hammam (Alaa el Habashi)

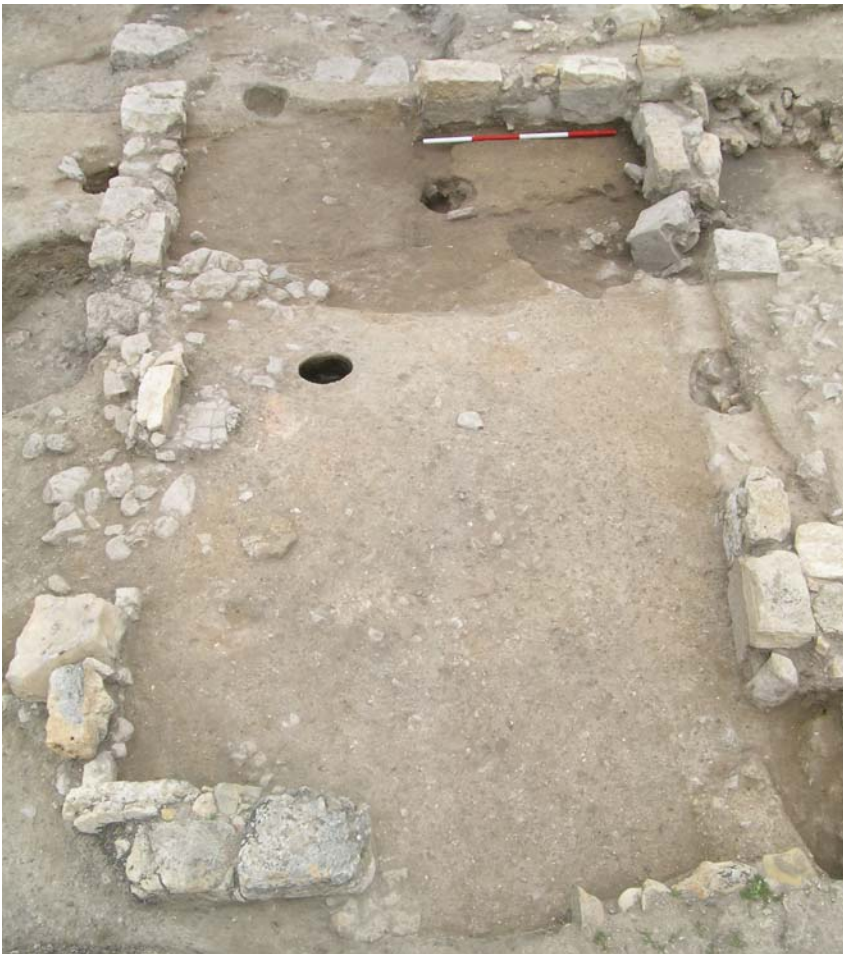
Fig. 2: Building L, from the south

A third building, L, has less clear stratigraphic links to F, but it may be assumed to be of roughly the same period. Here, the initial terracing clearly revealed earlier buildings, for two of the walls were built along walls founded much deeper. The other walls were roughly built, without foundations and reinforced at intervals with wooden posts. The floor of the room was cut down slightly into the surrounding clay. Measuring 8.5 x 4.2m., the plan of the building is relatively clear, although, again, the position of the door is uncertain: it was probably to the south. The southern 2/3 of the space was floored in beaten-earth, with a hearth and a domestic silo to the west. A dividing wall separates this space from a room with a very irregular

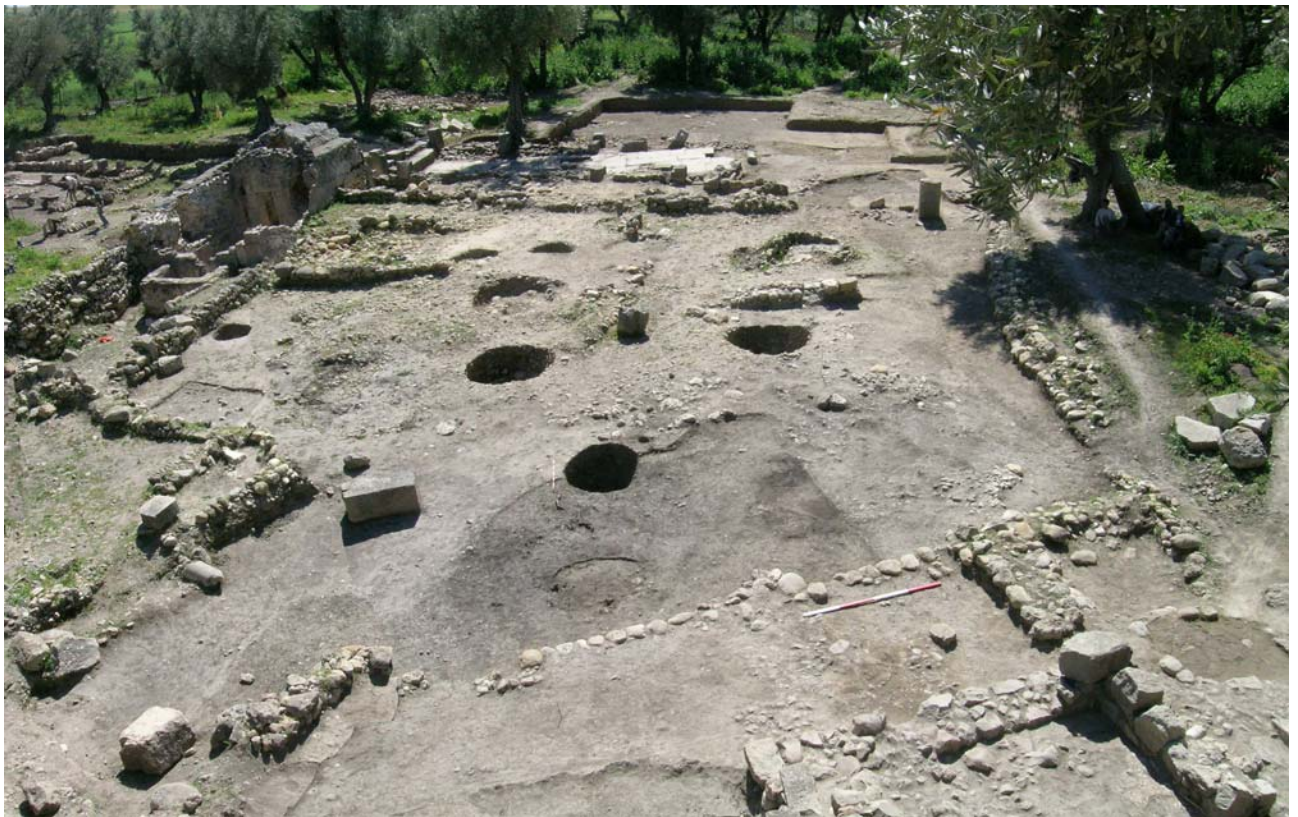
Fig. 3. Area 4000, looking west.

This year the site around the Islamic baths, which we take to be the settlement created by Idris I, was expanded, with a broad new area exploring building I under the direction of Helen Dawson, and an extension to the west of the bath building to confirm that there were no annexed structures. This, and the continuing excavation of the area to the north of the building, was directed by Guy Hunt. Finally, Tarik Moujoud continued his excavation of a deep trench linking the site to the Roman walls. The whole area uncovered now measures almost 2000 sq. m.

To the west of the baths, towards the oued, no further buildings were recovered, although a stony compacted surface may indicate a road. This seems to have been the western limit of the site, confirming the evidence of the small sondage carried out to the southwest in 2001. To the north, enclosed between the two wings of the baths and the rampart, lies the large open area occupied by pits. At least 10 of these were substantial grain silos, cylindrical in form and as much as 2 metres in diameter, with depths of up to 2 metres. Only in a few cases was any treatment of the sides observed, although in one case a clay coating filled in the spaces between the gravels of the underlying alluvial deposits. These pits appear to follow relatively regular alignments, and in general do not cut each other. This suggests that they were roughly

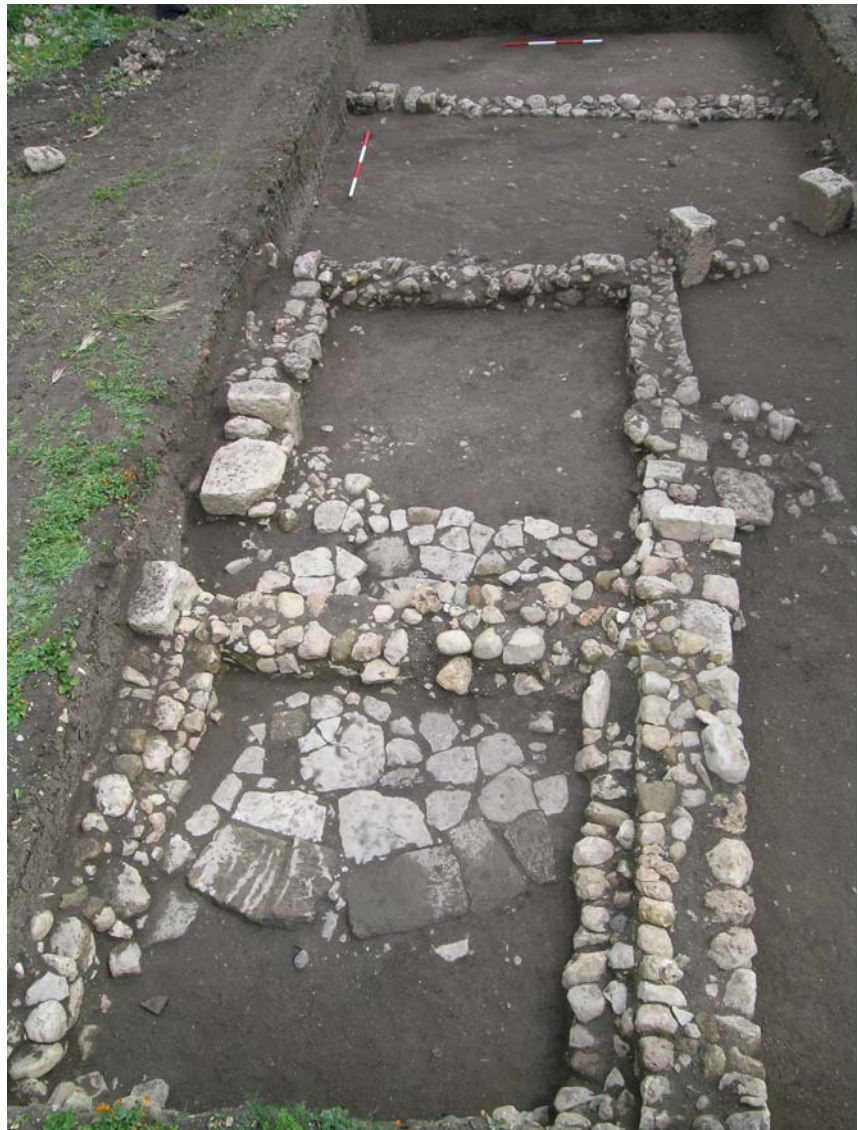
Fig.4. The west wing of Building I, with the entrance to the courtyard.

The courtyard was reached by a large door marked by two orthostats at the southeast corner of the building. This door is angled at 45° to the other walls of

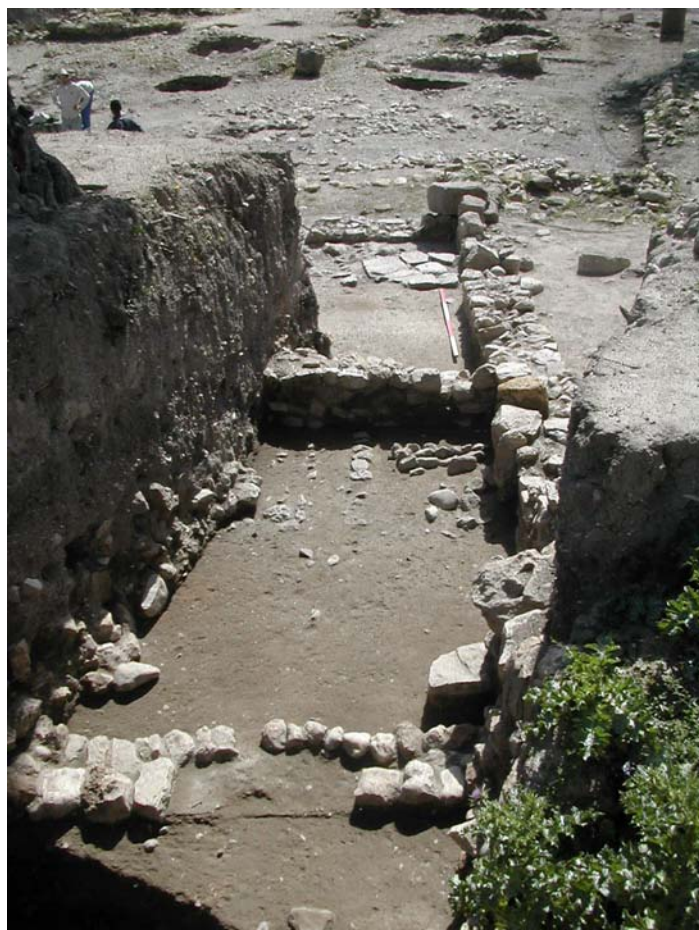
Fig. 5. The house next to the Roman rampart, c. 900.

number of houses, apparently composed of one or two rooms. We have a very patchy view of this phase, due to the damage caused by the earlier excavations. However, the house excavated near the rampart gives us a good view of the plan of these buildings: again, two substantial rooms are placed end to end, with a door on the north side. In the case of this building the east wall apparently abutted the rampart itself, at this point partially destroyed, with its facing removed and only the rubble core still standing. This house used partial paving on its floors, set into the usual pinkish plaster. Outside it lay a horseshoe-shaped basin, lined with hydraulic mortar. Traces of two other such basins were found on the site. Their explanation is not certain: possibly they were used for washing, although they might be interpreted as watering troughs for animals. Some of the smaller pits may belong to this phase, but, in general, the larger silos are sealed by walls or layers associated with the domestic use of the site. Finally, the bath building, too, seem to have been abandoned, as later walls cross it at two points. A thin layer of yellow clay seems to separate the use of the baths from the domestic occupation of the site. This may have been due to disastrous flooding: in fact, the orthostats of the west wall of the *frigidarium*, the wall nearest to the Oued Khomane, are sharply tilted to the north, suggesting the violent thrust caused by the torrent.

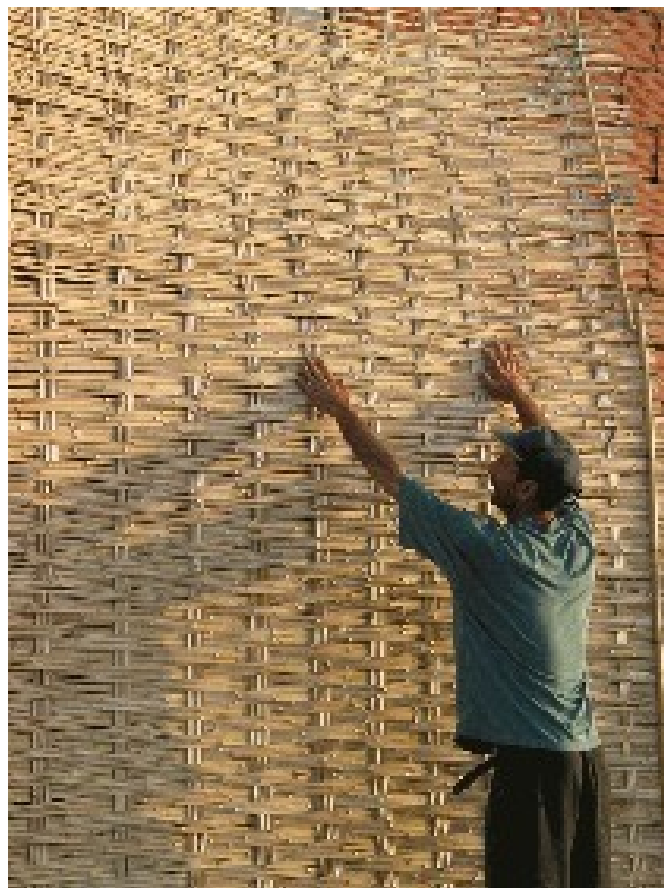
Abdil Nabi, the qassab, weaving one of the three 5.50x2.08 M reed mattes used in covering the newly construction vault (Photo: A. el-Habashi)

Reed, locally known as “*qasab*,” grows along the creek that runs on the southern and western side of Volubilis. The reed is usually harvested at the end of the rainy season, and left to dry during the summer time. It is traditionally used in several construction activities, the most common of which in the area of Zarhoun is in fencing. It is also used for weaving mats to cover sheds in front of shops. Weaving reeds is so traditionally rooted that almost most of the workers involved in the building construction knew how to do it. There are also specialists, locally known as “*qassab*.” Reed mats were selected to cover the structural wooden vaulted frames, as they are light, and, if intricately woven, sufficiently flexible for the profile sought for the vault of the Hammam. Since it is a traditionally rooted craft, reed mats can be reproduce in the future if necessary. Moreover, mats offer the option of either leaving them exposed internally or covering them with a continuous layer of gypsum plaster. In order to achieve a certain longevity for the material and to prevent termite to attack it, the reeds, after being cleaned and sliced, were submerged for 24 hours in a diluted solution of sulphuric acid. The treated reeds were then washed, dried, and woven into three 5.50 x 2.08 M mats. The dimensions of the mattes were calculated so that they would cover the vaulted structures with at least 10 CM of overlap.

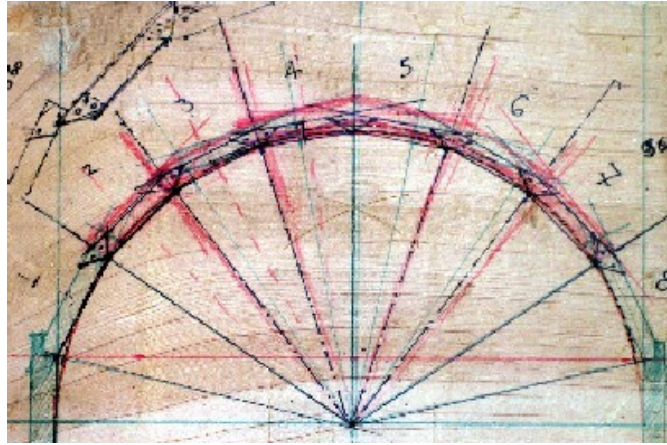
Drawing of the design of the wooden frames as modified on site to suite the exact dimensions of room 5 and to follow the profile of the existing vault in room 4 (A. el-Habashi)

As agreed in the work plan, a lightweight vault is to be reconstructed over room 5, and extended to join with the eastern side of the existing vault in room 4. In order to achieve this, nine structural wooden frames were designed in such a manner that they would rest on wooden posts (8x15 CMS in section), supported by a leveled area of the ruined walls. In areas where the remains of the vault still exist, a wooden seat fixed on top of these received the wooden vaulted frames. No wall reconstruction were sought to even the posts heights. Each of the posts, therefore, was tailored exactly to fit into its designed position. Minimum leveling using crushed bricks and lime mortar was enough to provide the seats required for the posts. The profile of the ruined walls is, therefore, conserved in order to emphasize on the fact that the new roof is a new intervention that is totally reversible.

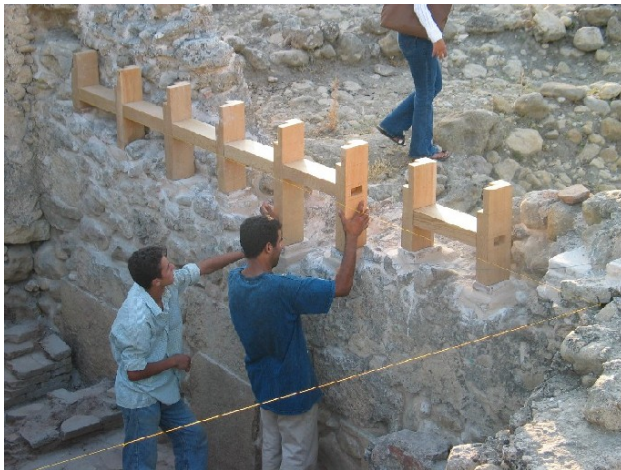
Left: The carpenter and his assistant fixing the posts directly on the ruined walls. Note the different height of the posts to compensate the uneven profile of the ruined walls (A. el-Habashi);

It should be emphasized the frames rest on the walls without any means of fixing them. It is only the weight of the frames along with its covering roof that is keeping it in place. Two tie beams fix the top of the arched frames to the top of the wall that separate rooms 4 and 5. The purpose of these is to prevent any horizontal displacement of the frames. The span between the axes of the frames is 50 cm., so that the frames provide sufficient support for the covering mats and the layer of roofing mortar above without any bowing or deflection of the woven reeds.

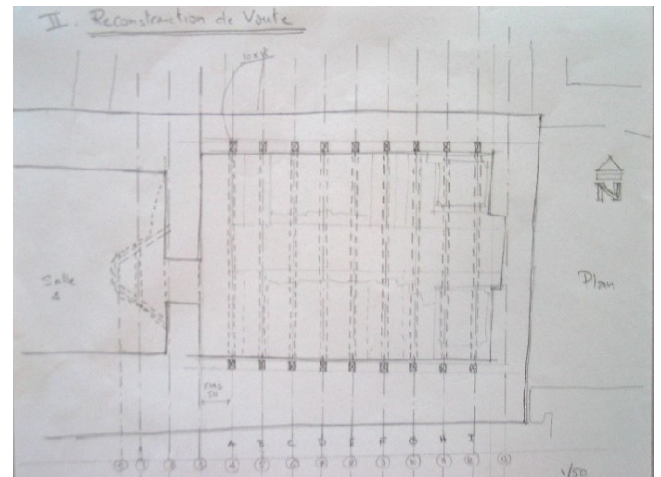
Right: the plan of room 5 with the design of the nine vaulted wooden frames (A. el-Habashi)
